Safety, Health and Environment
National Authority

# SHENA ENFORCEMENT FINDINGS & COMPOUND FINES

# WORK AT HEIGHT

# INSPECTION FINDINGS WORK AT HEIGHT

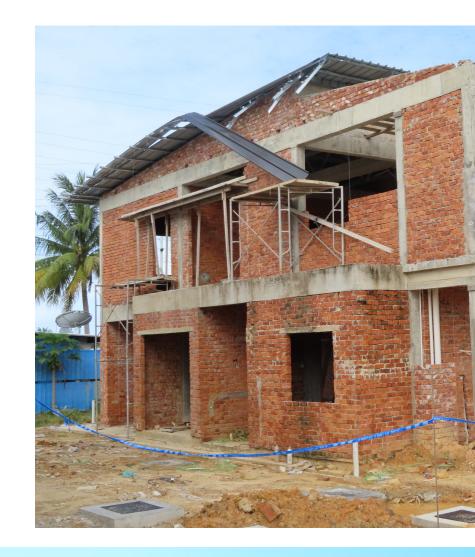
# CASE STUDY 1: FALL FROM ROOF LEADING TO FATALITY AND SERIOUS INJURY

A fall from a height incident involving two construction workers occurred. One worker was on the roof of an under-construction house, while the other was on the ground floor. The incident occurred when the worker on the ground floor, who was not wearing any Personal Protective Equipment (PPE), went up to the roof and slipped, falling headfirst onto the drainage. This fall caused another worker on the roof to lose balance and fall.

- ☐ Inadequate fall prevention plan and no appropriate PPE used for work at height.
- Absence of work procedure, permit to work, and risk assessment.
- No onsite supervision during the works.
- Lack of competency and training for the workers performing working at height.

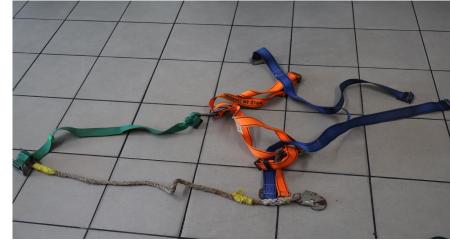
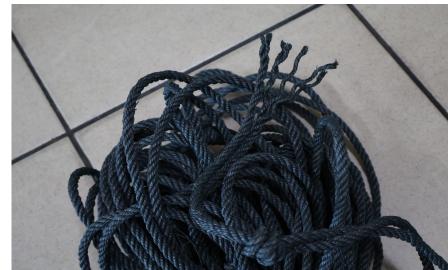
# CASE STUDY 2: FALL FROM ROOF LEADING TO FATALITY

A worker was cleaning a roof tiles when he lost his balance and fell from the rooftop approximately 6 m above the ground. Although, the worker was wearing a safety harness, he used a window safety grill on the ground floor as an anchorage point. The worker sustained severe head injuries and passed away a few days later.

- ☐ Lack of formal safety procedures i.e., risk assessments, and documented safety measures.
- ☐ Inadequate fall protection i.e., safety harness was not properly anchored.
- Lack of competency among workers.
- Deficiencies in emergency response.

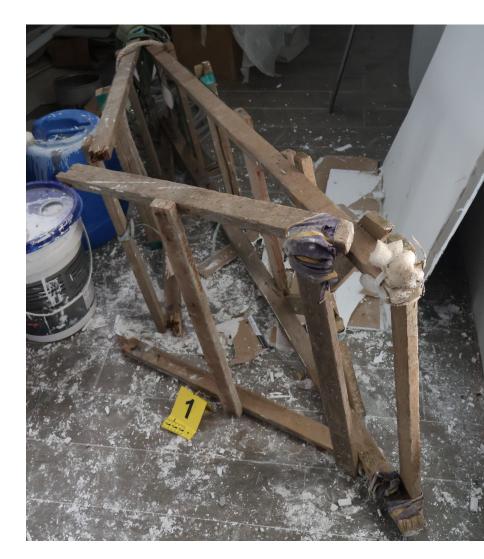
# CASE STUDY 3: FALL FROM HEIGHT LEADING TO FATALITY

A construction worker was performing ceiling works using a makeshift wooden ladder (about 1.92 m) when the wooden ladder broke causing him to fall headfirst onto the concrete floor. The DP succumbed to his injuries after 2 weeks of hospitalization with immediate cause of death was identified as a "traumatic head injury".

- ☐ Use of improper equipment i.e., a makeshift wooden ladder with questionable integrity.
- No use of PPE i.e., safety helmet
- Lack of risk assessment for the specific task.
- Lack of supervision and lone working.

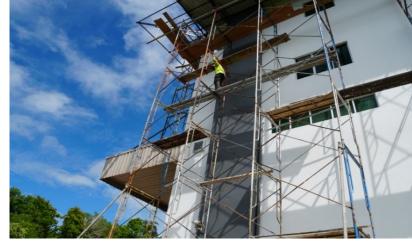
### WORK AT HEIGHT SCAFFOLD ARRANGEMENT

- Absence of fall prevention measures, such as guardrails or edge protection.
- Lack of fall protection equipment, including fall arrest systems or lifelines.
- Unstable working platforms that are often narrow, unsecured, or poorly supported.
- Improper access and egress, posing additional risks during entry and exit.
- Inadequate or unstable structural support, compromising overall safety at height.

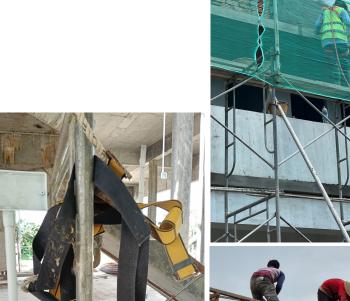
# WORK AT HEIGHT WORKING ON ROOF AND BEAM

- Absence of adequate fall prevention measures (e.g., guardrails, barriers).
- **X** Fall protection systems (e.g., harnesses, anchor points) were not implemented.

- Restricted or inadequate working platforms limiting safe movement.
- ★ Uneven and slippery surfaces increasing the risk of slips, trips, and falls.

- ★ Safety harnesses and personal protective equipment (PPE) were either not provided or not properly worn.
- Incorrect usage of safety harnesses.
- Damaged or poorly maintained safety harnesses.
- **X** Absence of proper anchorage points.

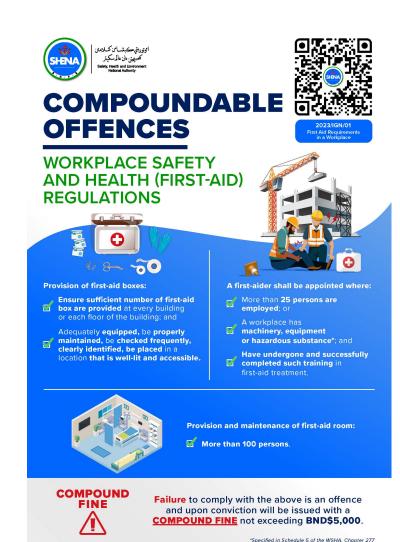
## FIRST AID ARRANGEMENTS

- **X** First aid box not available
- **X** First aid box found empty
- Inadequate / nonrecommended content
- Used and contaminated contents

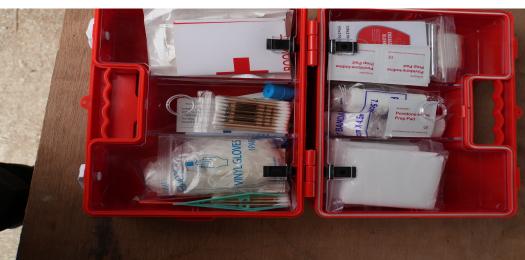
# FIRST AID ARRANGEMENTS

- **✓** First Aid Box available on site
- **✓** Identified as a first aid box
- **✓** Adequate content

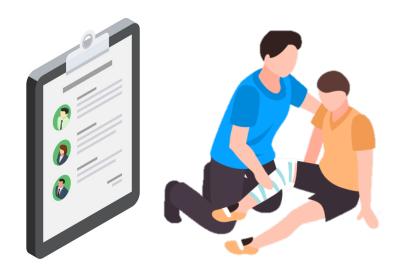
## FIRST AIDER ARRANGEMENTS

- **✓** Competent first aider appointed
- **✓** First aider available on site
- **✓** Notification of the first aider on display
